Tokyo thermochemical ind.co.,ltd

Measurement of thermal insulative function

Implement place : Bakery Tyrol's bread baking oven door

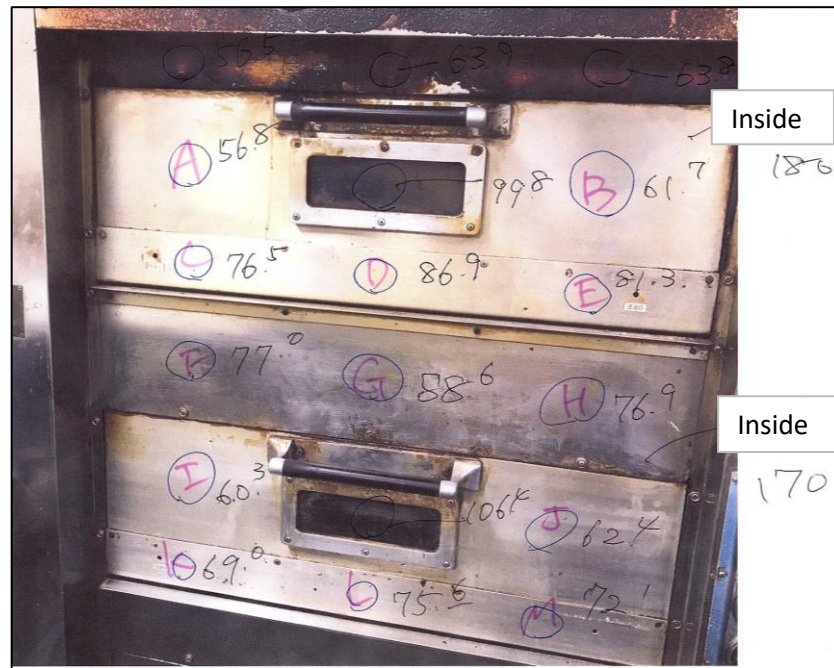
Bread baking oven door(Place for temp measurement)

○Please refer to next page for checking place where is measured temp

Date of painting Jul 28th, 2022		Measuring temp date Jul 29th,2022			Date of measurement Feb 6th,2023		Measurement of coating thickness for each painting process(μ m)						
Place for temp measurement		Surface temperature($^{\circ}$ C)			Surface temperature($^{\circ}$ C)		Primer A2101BK3S	After 1 time Middle coat A1601GR01S	Middle coating itself	After 2 time Middle coat A1601GR01S	Middle coating itself	After top coat A2101SL01M	Top coat itself
		Before painting	After painting	Temp difference	After 6month from painting	Temp difference							
Upper part (row)of oven Inside temp About 180 $^{\circ}$ C	A	56.8	50.5	6.3	45.4	11.4	17	549	532	1254	705	1289	35
	B	61.7	53.1	8.6	47.2	14.5	11	630	619	1064	434	1121	57
	C	76.5	68.5	8.0	60.9	15.6	23	680	657	1014	334	1094	80
	D	86.9	76.8	10.1	73.6	13.3	29	720	691	1287	567	1336	49
	E	81.3	72.8	8.5	68.2	13.1	20	650	630	1178	528	1269	91
Middle part (row)of oven	F	77.0	68.6	8.4	61.8	15.2	23	750	727	1322	572	1394	72

G	88.6	73.3	15.3	64.6	24.0	27	690	663	1297	607	1377	80
	H	76.9	66.8	10.1	60.7	16.2	23	565	542	1315	750	1368	53
lower part (row)of oven Inside temp About 170 $^{\circ}$ C	I	60.3	51.7	8.6	47.8	12.5	21	563	542	1181	618	1235	54
	J	62.4	50.9	11.5	48.3	14.1	19	510	491	1289	779	1378	89
	K	69.0	59.2	9.8	55.4	13.6	21	509	488	1147	638	1206	59
	L	75.6	65.1	10.5	62.6	13.0	22	580	558	1141	561	1195	54
	M	72.1	64.5	7.6	62.8	9.3	27	486	459	1083	597	1144	61
Average coating thickness/Temp		72.7	63.2	9.5	58.4	14.3	21.8	606.3	584.5	1197.8	591.5	1262.0	64.2
Way of painting							Roller	Brush(water dilution 10%)		Trowel (no dilution)		Brush

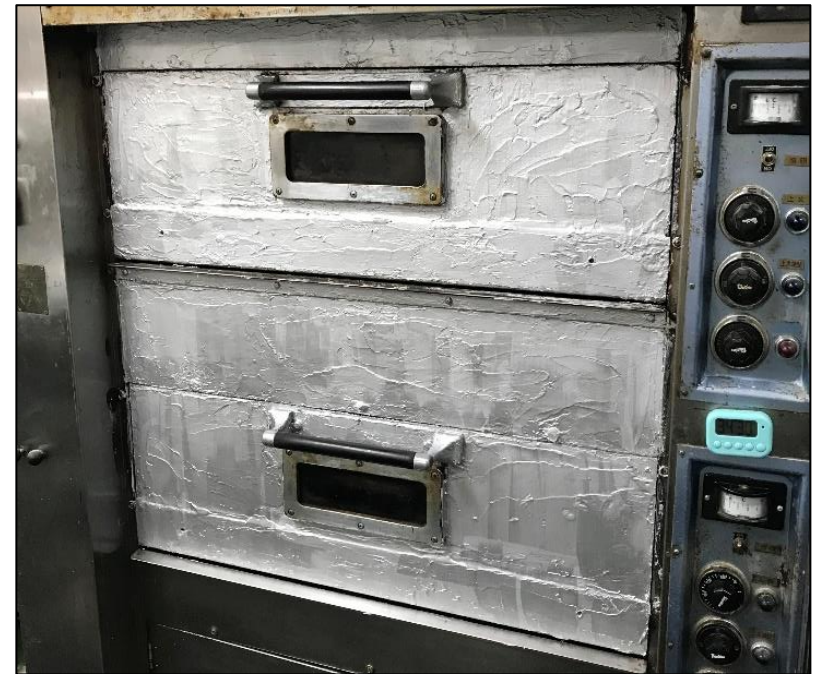
After painting thermal insulation paint on bread baking oven door

Aug 10th,2022 Although the decreasing of surface temp is around 10°C, If someone stand in the front of door ,the thermal radiation was reduce, so could feel cool wind from Air conditioner well. Thermosin heat insulation paint has effect to improve working environment under high temp.
