Tokyo thermochemical ind.co.,ltd

Measurement of thermal insulative function

Implement place : Bakery Tyrol's bread baking oven door

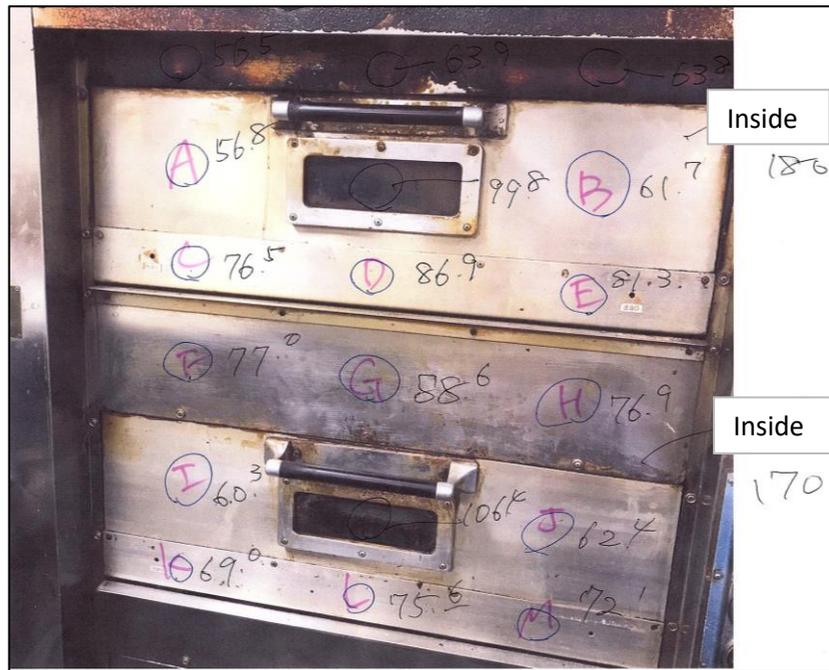
Bread baking oven door(Place for temp measurement)

○Please refer to next page for checking place where is measured temp

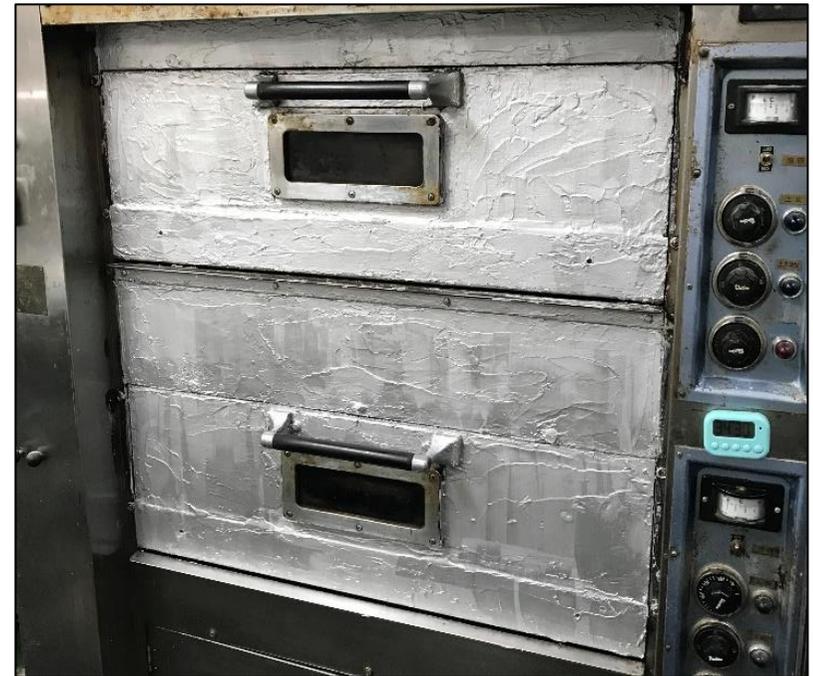
After painting thermal insulation paint on bread baking oven door

Aug 10th,2022 Although the decreasing of surface temp is around 10°C, If someone stand in the front of door ,the thermal radiation was reduce, so could feel cool wind from Air conditioner well. Thermosin heat insulation paint has effect to improve working environment under high temp.
